**ANALYTICAL AND EXPERIMENTAL INVESTIGATION FOR  
DISTORTION-INDUCED FATIGUE IN STEEL BRIDGES**

Project No. TPF-5(189)

Submitted to the graduate degree program in Civil Engineering  
and the Graduate Faculty of the University of Kansas  
in partial fulfillment of the requirements for the degree of  
Doctor of Philosophy.

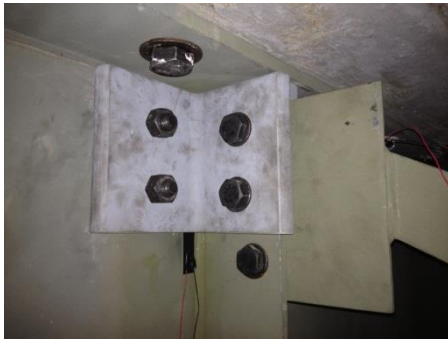
**Figure 4: Retrofit as applied to top web-gap in test specimen.**

The investigated retrofit contained two angles providing attachment between the connection plate and girder web with a backing plate on the opposing face of the web. Two L152x152x19 mm [L6x6x3/4 in] angles were bolted to the connection plate and girder web while a 457x457x19 mm [18x8x3/4 in] back plate was used to distribute out-of-plane forces over a large web area, as shown in Figure 4 schematics.

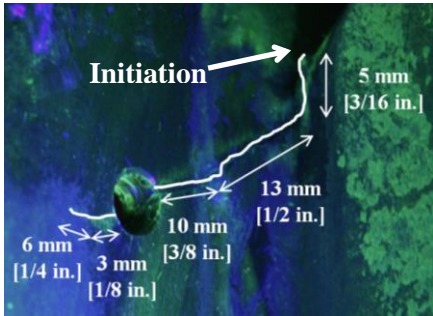
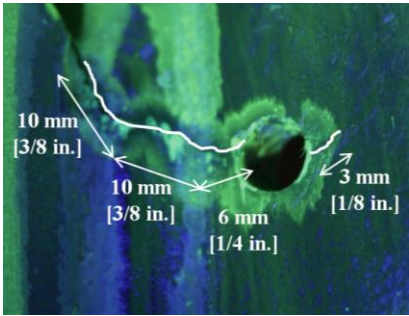
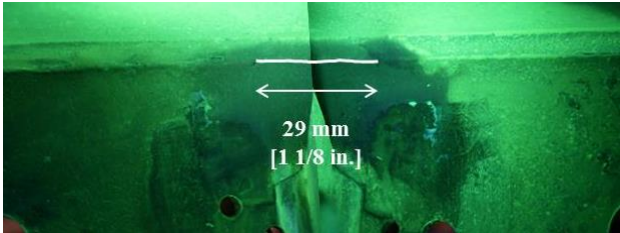
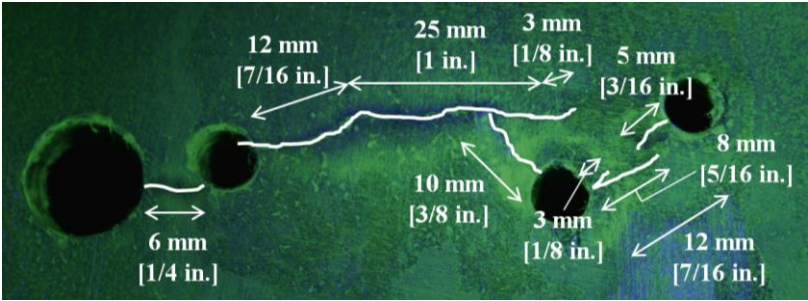
**Table 3: Cracking at End of Trial 6 (6,011,097 Cycles)**

In Trials 1S and 1N, cracking initiated at the weld near the clip in the transverse connection plate. Cracking progressed diagonally down through the weld until reaching the girder web.

During Trial 1S, cracking progressed down the weld toe in the south girder until branching out into a spider crack. These spider cracks propagated outward away from the

transverse connection plate. On the left side of the transverse connection plate, cracking also progressed down web at the weld toe. North girder cracking progressed slightly differently, in that cracks did not propagate into the web until Trial 2N and did not follow the weld toe. Longitudinal cracks at the flange-web weld were found in Trials 6N and 6S. The point of initiation was unclear for the longitudinal cracking, since the north girder longitudinal cracks were significantly large when discovered at the end of Trial 6N. Table 3 shows the cracking patterns at the end of Trials 6S and 6N.

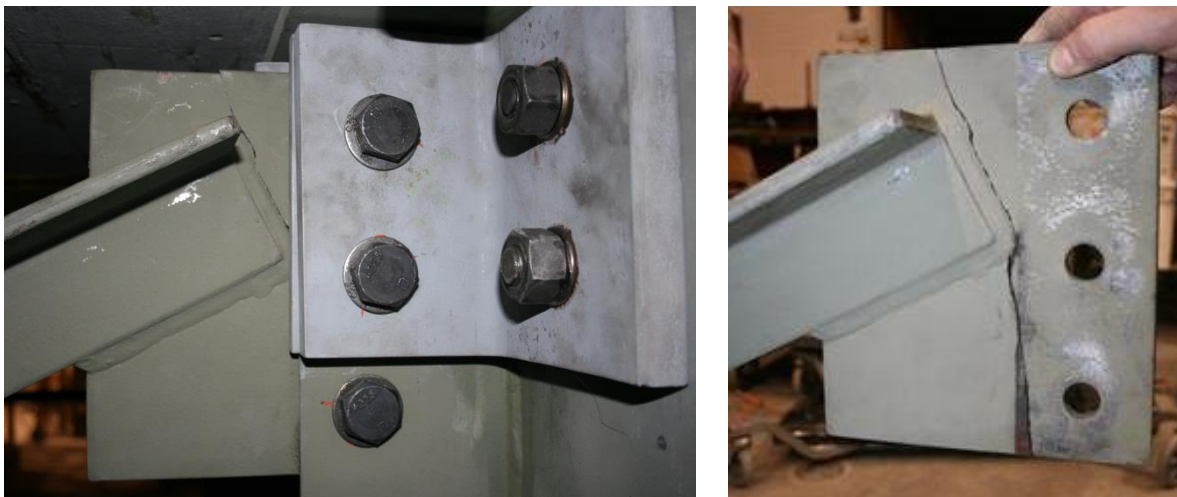
**Figure 12: North cross frame failure during Trial 4N.**

Small crack arrest holes with a 6-mm [1/4-in.] diameter were drilled at the crack tips before the start of Trial 4N, and the angles-with-plate retrofit was reapplied and the load range was increased. Approximately 650,000 cycles into Trial 4N, a faint clicking noise was noticed originating from the connection plate in the north girder. After inspection of strain data, no significant change in bridge response was noticed. However, when the bridge was visually inspected at 1.06 million cycles into Trial 4N, the cross frame between the north and middle girders was found to be cracked completely through at the tab plate, as shown in Figure 12.

During inspection, there was no evidence of fretting due to the angle-with-plate retrofit. Measured strains in the cross frame element prior to fracture were approximately  $375 \mu\epsilon$ , which, based on modulus of elasticity for steel of 200 GPa [29,000 ksi], correlated with an approximate stress of 75 MPa [11 ksi]. It is estimated that the crack started at the bottom corner of the weld toe where the cross frame diagonal member (AT) framed into the tab plate.

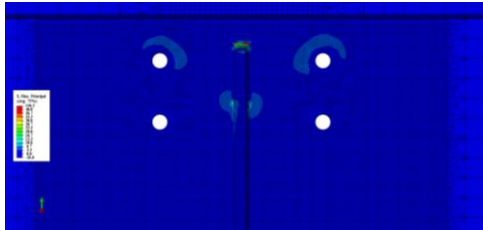
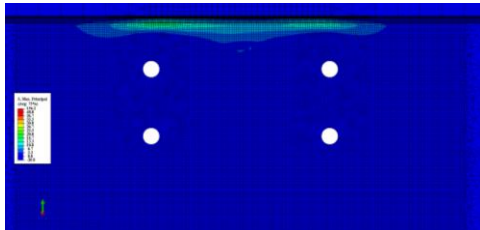
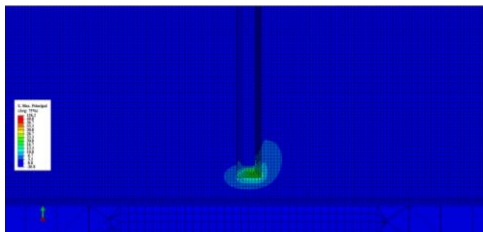
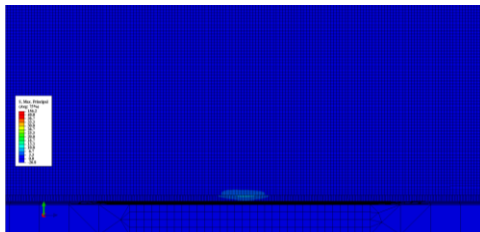
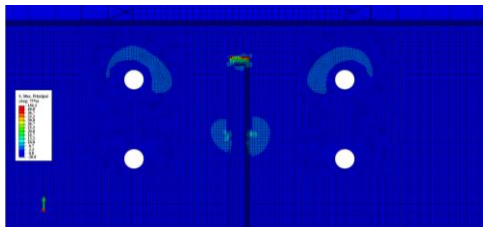
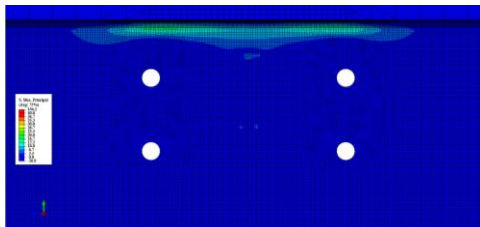
Uncracked, Unretrofitted Model (UCracks3inRet1-pt5-Bolts-60k)		
	Interior	Fascia
South Girder

North Girder

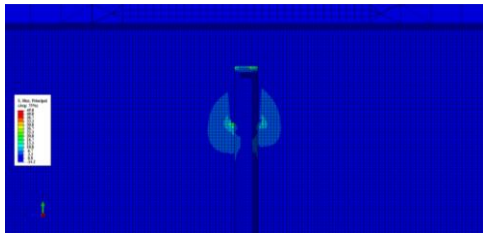
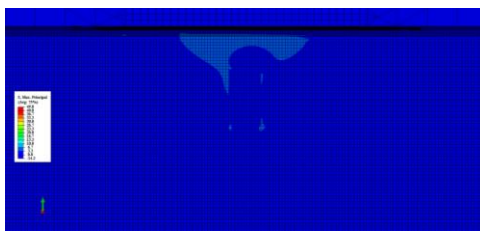
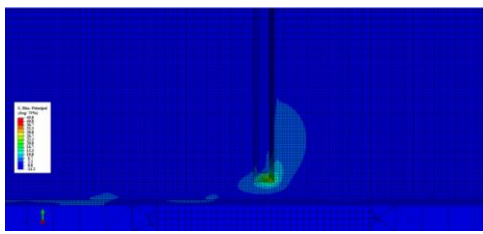
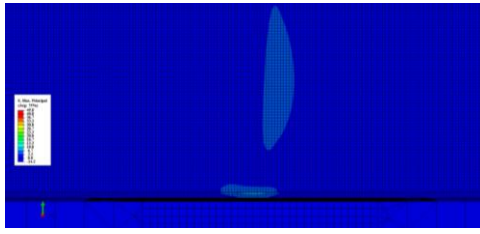
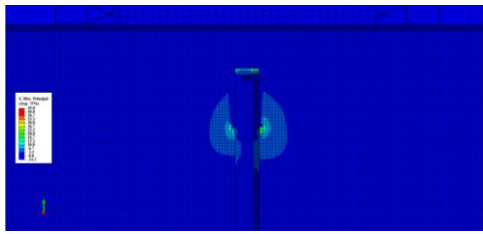
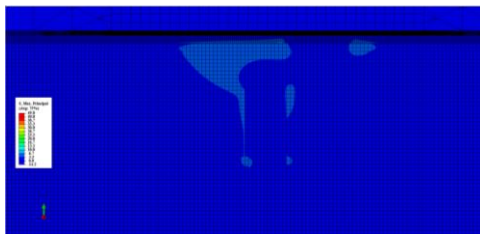
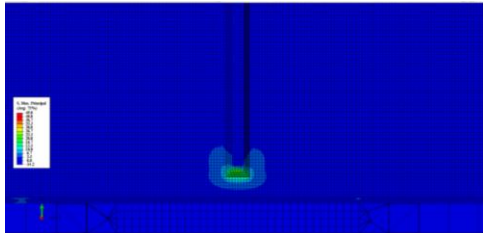
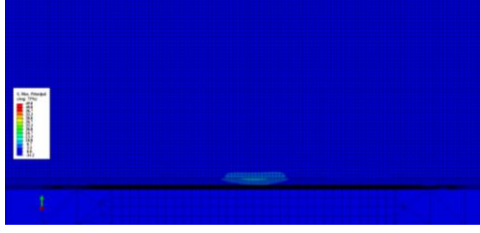
Table D. 35: 2 in. Horseshoe Crack, Angles to Top Flange with Tension Model

UCracks2inRet2TopFlange-60k		
	Interior	Fascia
South Girder

North Girder

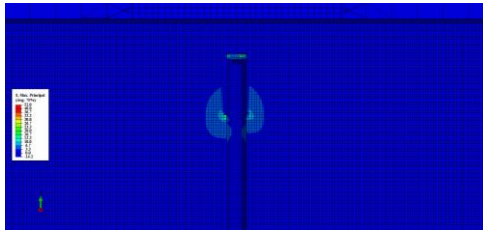
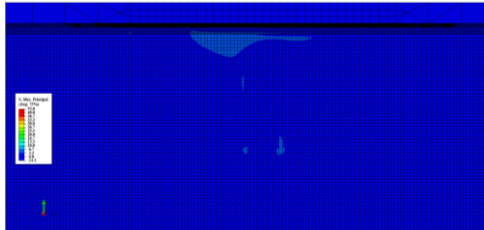
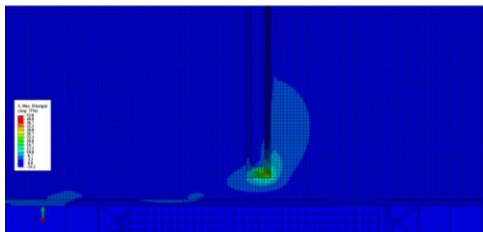
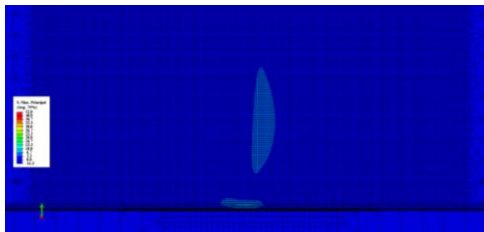
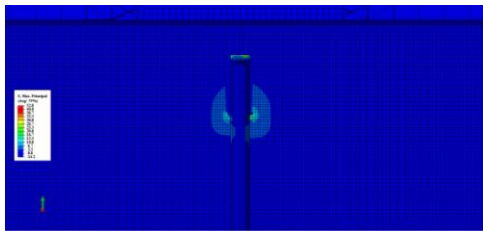
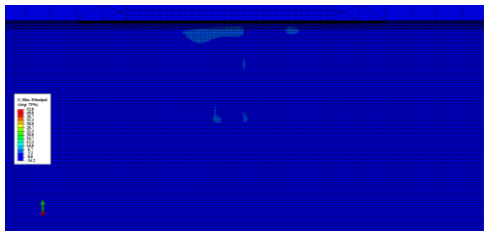
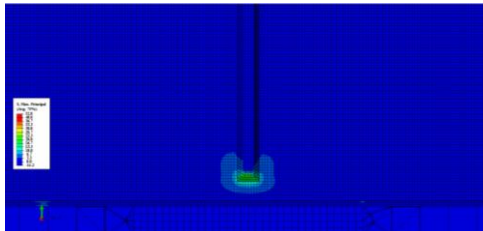
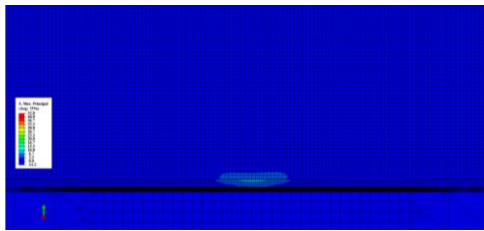
Table D. 36: 2.5 in. Horseshoe Crack, Angles to Top Flange with Tension Model

UCracks2point5inRet2TopFlange-60k		Interior	Fascia
South Girder

North Girder
